SERVICE BULLETIN

BT02-007

2002 ALTIMA; BUZZ NOISE AT 2500-2700 RPM, MODERATE LOAD

2002 Altima (L31)

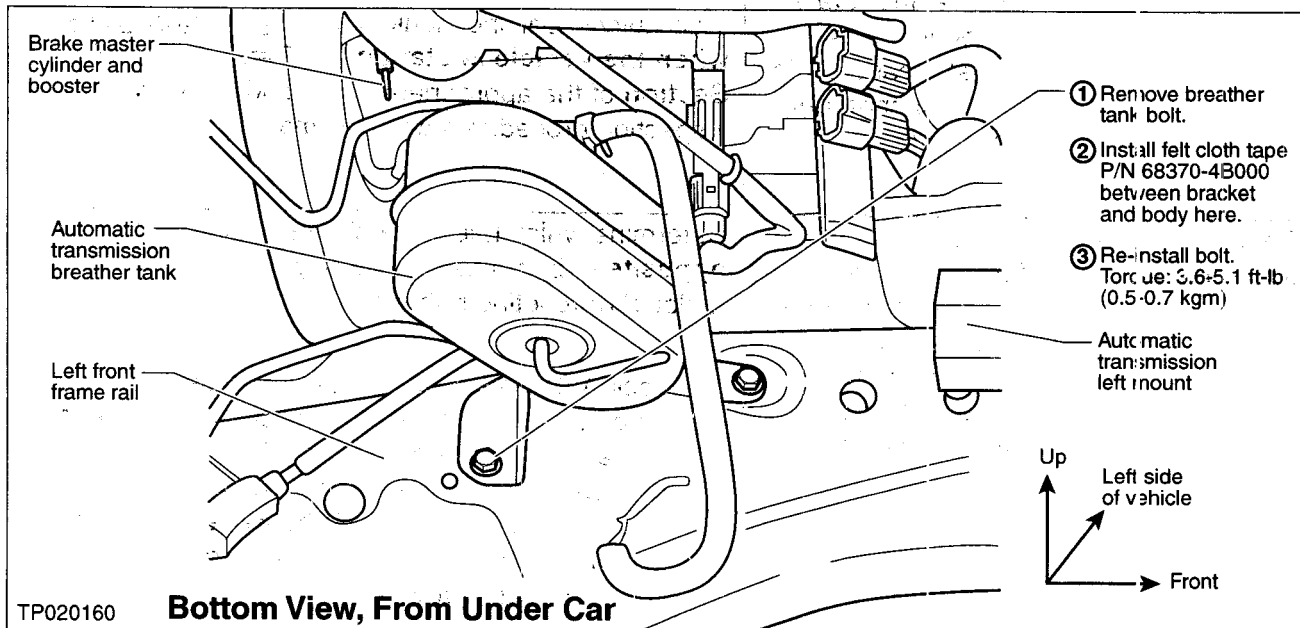
Figure 1

The automatic transmission breather tank bracket may be resonating against the left front frame rail, where it is mounted. Use the Service Procedure below to repair the incident if it should occur.

1. Verify the incident as described in the Service Information, above.
2. Locate the tank and repair the incident as shown in Figure 1.
